# CRICKET PAVILION AND OVAL WOLSTON PARK HOSPITAL CONSERVATION PLAN

*Prepared for:*  
Queensland Police Service  
Address

*Prepared by:*  
Project Services  
80 George Street, Brisbane

January 2008

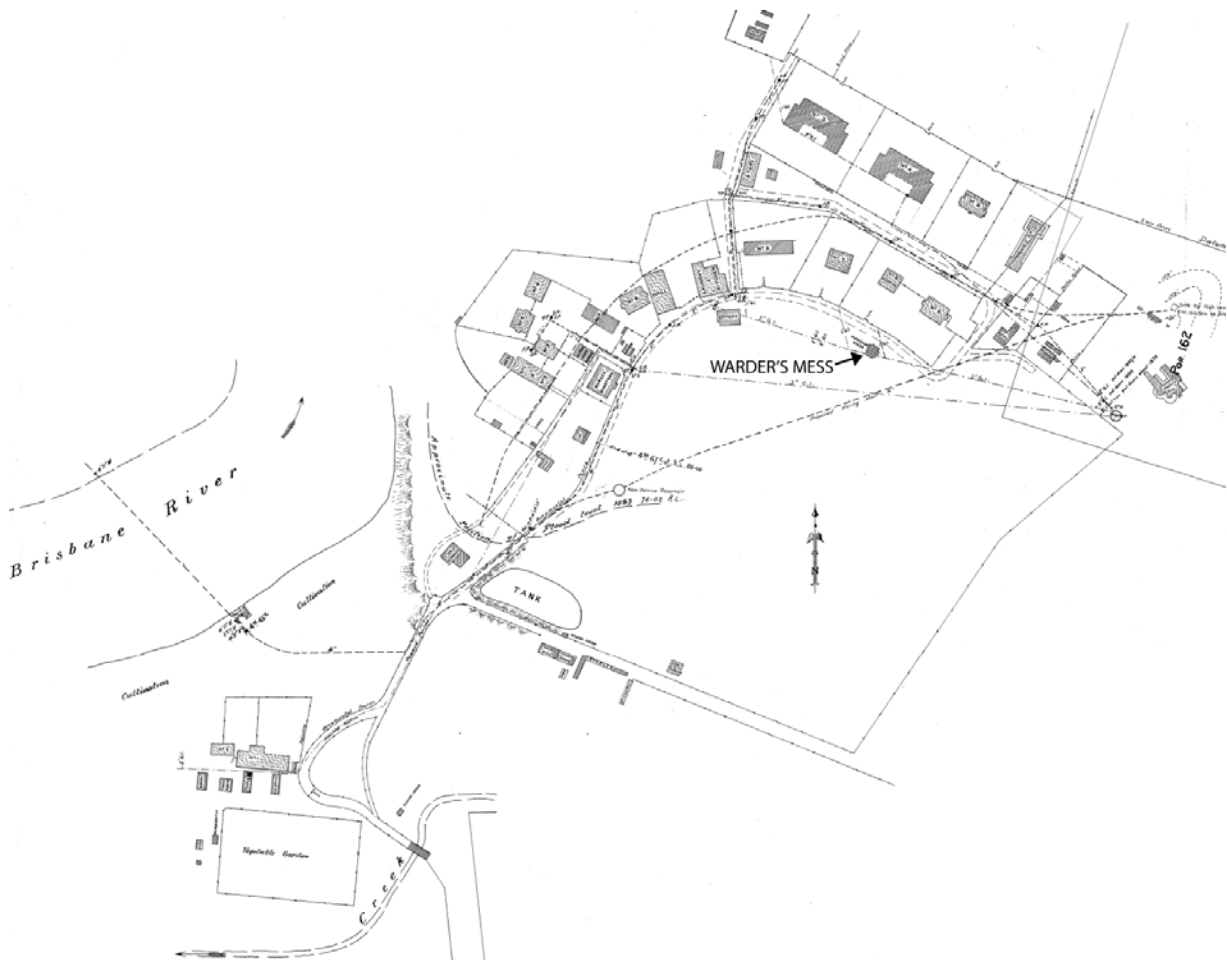
**Figure 5 Site Plan from 1896 showing location of warder's mess room building (QSA PD389 with note enlarged for this report)**

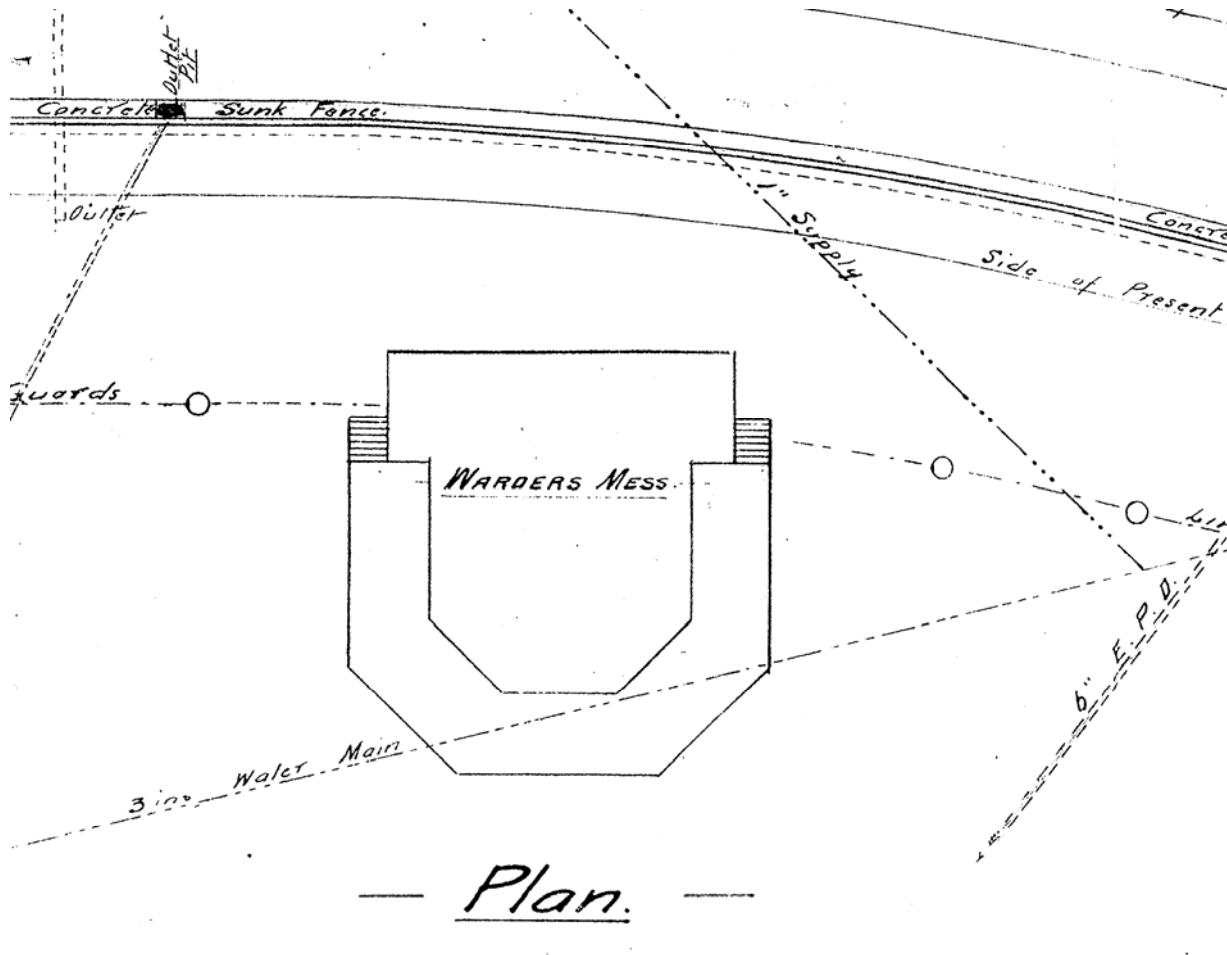
Figure 6 Part of a plan from 1909 which formed part of the documentation for a new sunken wall (QSA WOR/A695 Item ID 108407)

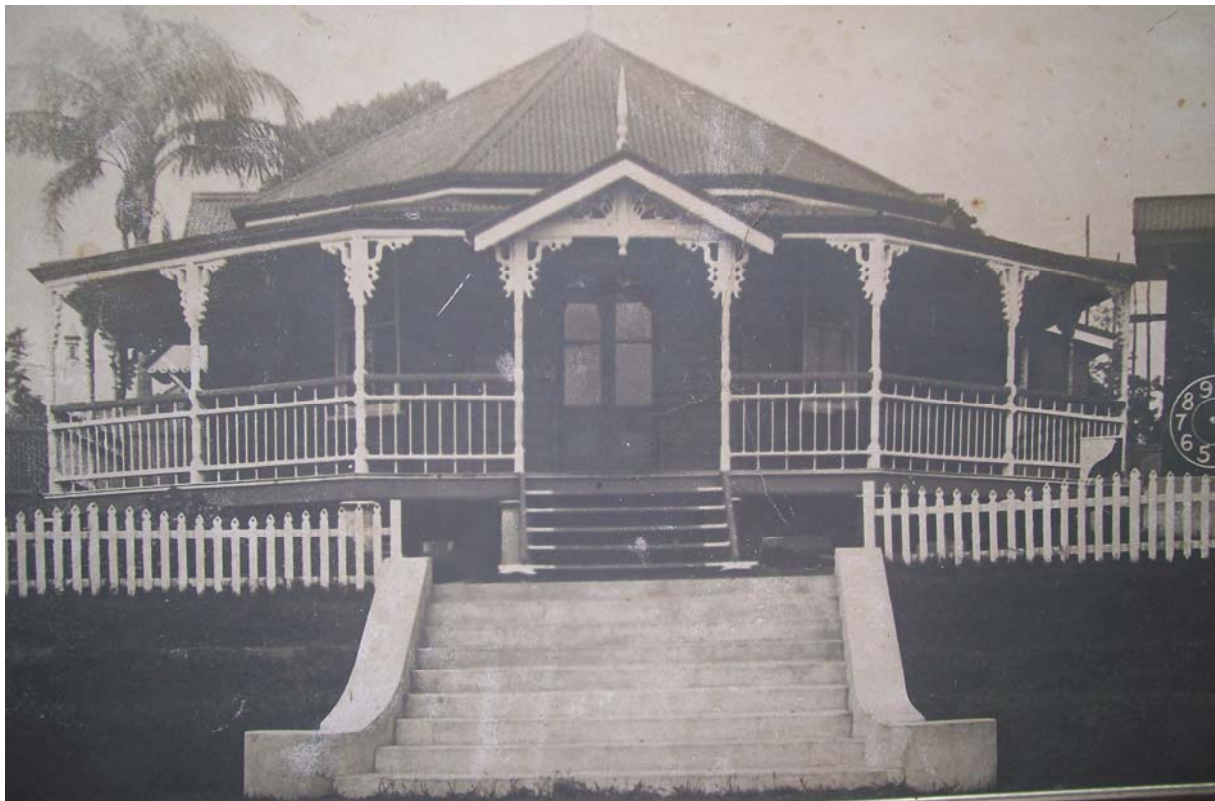
**Figure 10 Cricket Pavilion Building from the north in its first location with the score board now constructed on the right hand side and some substantial masonry steps (exact date unknown, but it is later than 1911 and before 1936). (framed photograph held by the cricket club)**

The photograph above shows the extensions after 1911 including the shower room to the west and the score board. The building is aligned slightly askew to the opening in the white picket fence and the concrete stair down to the recreation ground itself.

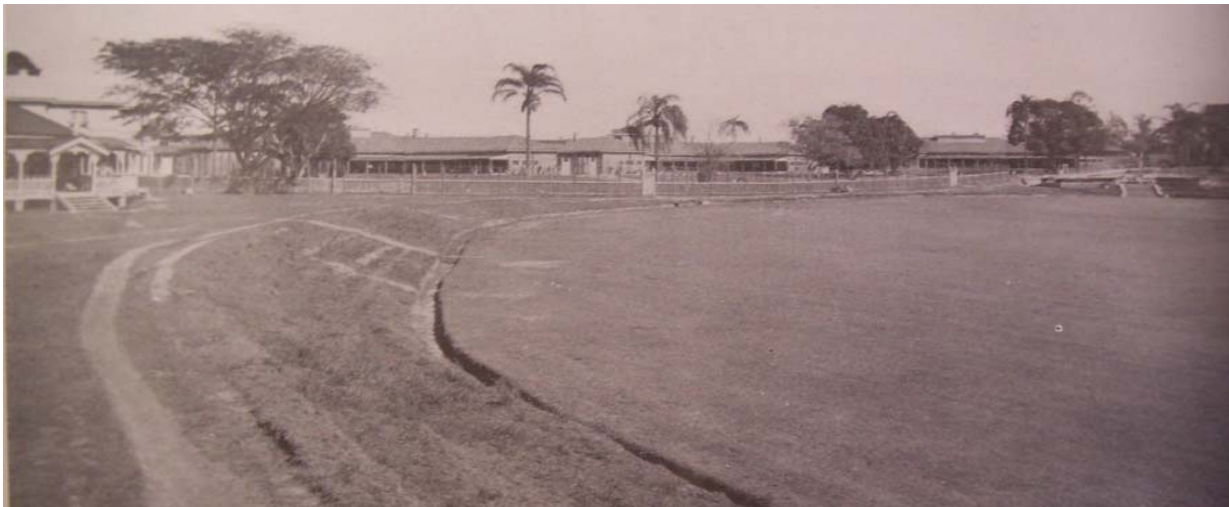
**Figure 11 Cricket Pavilion on its new site on the left hand side of the photo (part visible) and Bandstand behind the steps on the right. (Annual Report of the Superintendent of hospitals for the insane 1936, held by the library at Wolston Park Hospital)**

The photograph reproduced above shows the form of the bank around the oval and the deep earth drain around the bottom of the bank. The terraces in this north corner of the recreation ground are not as clearly defined as those in the eastern corner. The existing concrete stairs are not yet in place in the north corner and a grass terraced stair appears to have been set out but not completed. A 'goat track' runs around the top of the bank. Note the low fence between the crab shaped male wards in the distance and the recreation ground with gates from at least three of the ward gardens providing access to the grounds. The bandstand is in the east corner of the grounds with the concrete stair in front. This was just a platform without a structure. There is no planting around the cricket pavilion and limited planting in front of the wards. The score board is not visible.

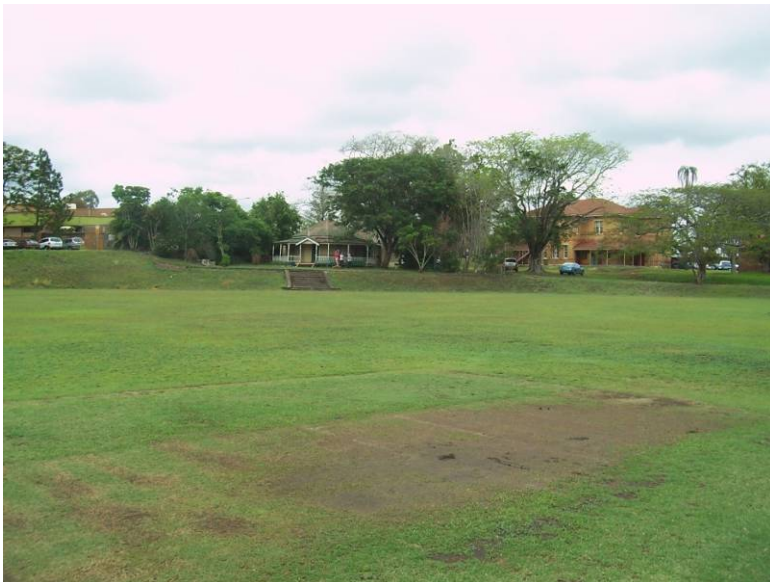
**Figure 15** Photo from the north showing cricket pavilion within its setting

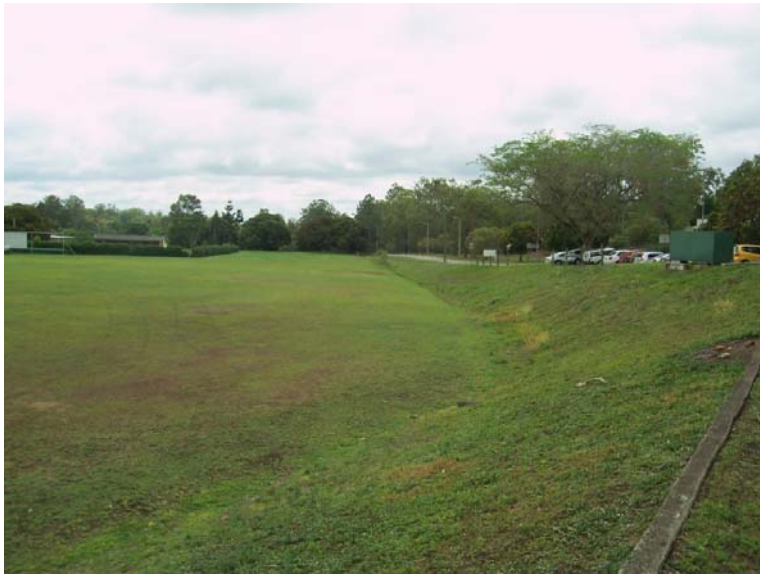
**Figure 16 Photo showing diminishing bank from the cricket pavilion platform in the southern corner towards the north west down the south east and north west boundaries of the recreation ground**

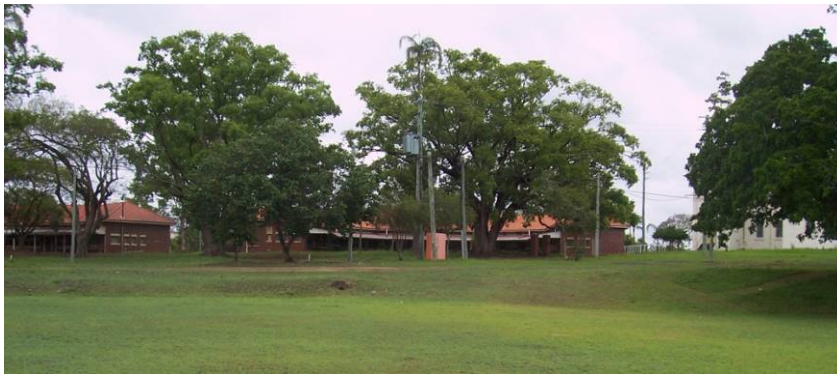
**Figure 19 Photo showing the west corner of the recreation ground today which was the first location of the cricket pavilion.**

This photo also shows the large shade trees which have been planted in front of the old male ward no. 8 which dated back to 1936. The view from the ward to the recreation ground was considered important. The cricket pavilion was moved from this location to the north corner of the recreation ground on account of it blocking the view of the recreation ground from this ward.

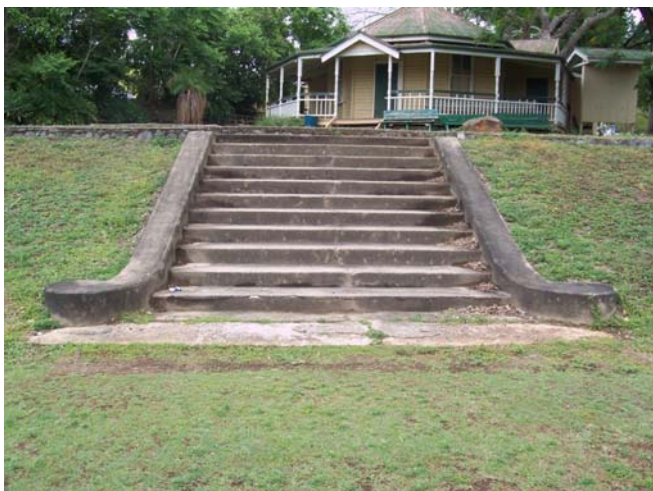
**Figure 20 Photo showing concrete stair with rendered dwarf walls in the south corner of the recreation ground. It is similar to the one that stood on the previous site but has two more risers.**

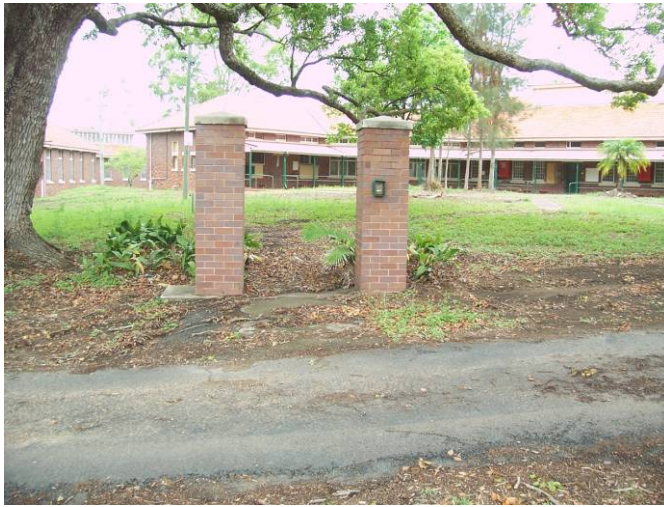
**Figure 21 Photo of two brick pillars in front of the old male ward no. 8**

There are two brick pillars in front of the old male ward no. 8 beyond the west corner of the recreation ground which are possibly indicative of the low fence and gate that show in photos and are mentioned in the annual report for the superintendent of hospitals for the insane in 1935-6.<sup>50</sup>

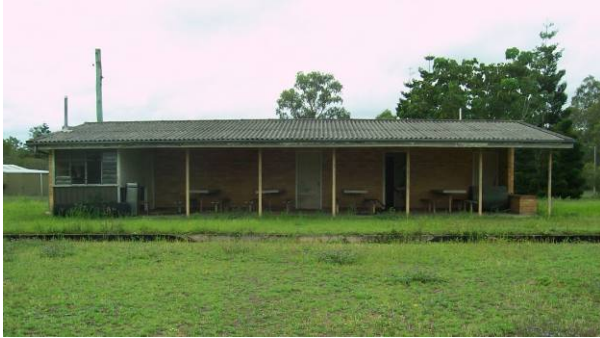
**Figure 23** Photo showing south western elevation of the bowling club building. This low, elongated building demarcates the south western edge of the recreation ground. It defines the edge of the cricket oval without being visually obtrusive. Beyond the bowling club building the land falls away down a relatively steep bank which can not be seen from the north east boundary.

The bowling club building dates to 1951/52 and is a low elongated brick structure with an asbestos roof that defines the north eastern edge of the recreation ground platform beyond which the landscape falls away to a fairly steep bank. The bowling club building and green is disused and in disrepair. The green is surrounded on the south west, north west and north east by a hedge.

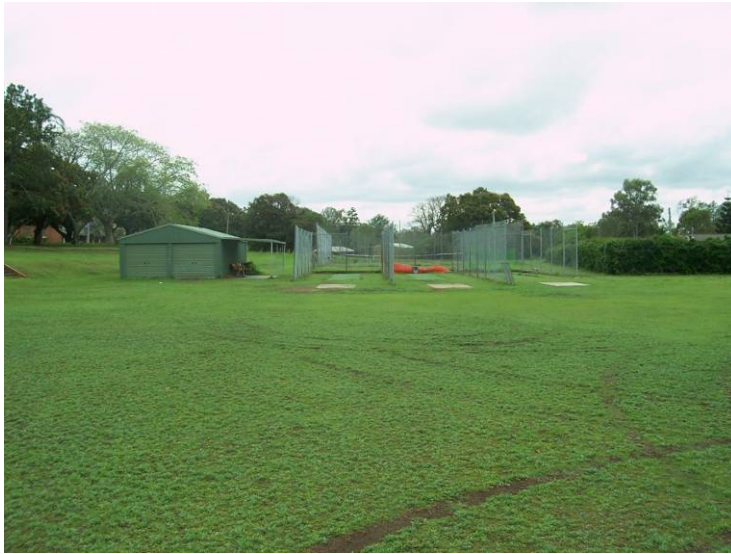
**Figure 26 Photo showing recent store building and cricket practice nets in the north corner of the recreation ground**

The store building in the north corner of the recreation ground is a recent building erected by the cricket club. It is a standard prefabricated corrugated metal shed on a concrete slab.

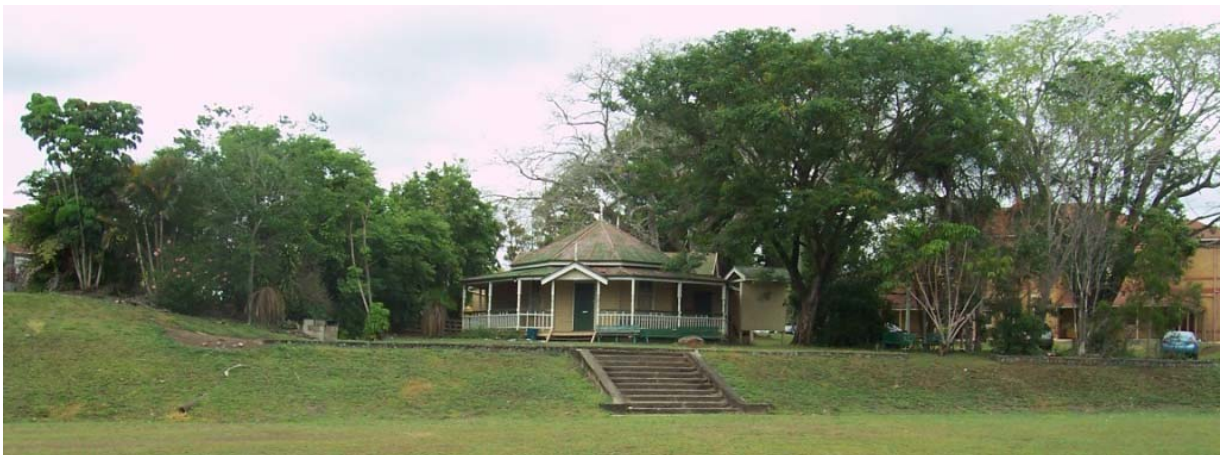
**Figure 27 Cricket Pavilion and raised triangular platform in the southern corner of the recreation ground today**

The cricket pavilion building is sited on a raised platform at the south corner of the site and faces north.

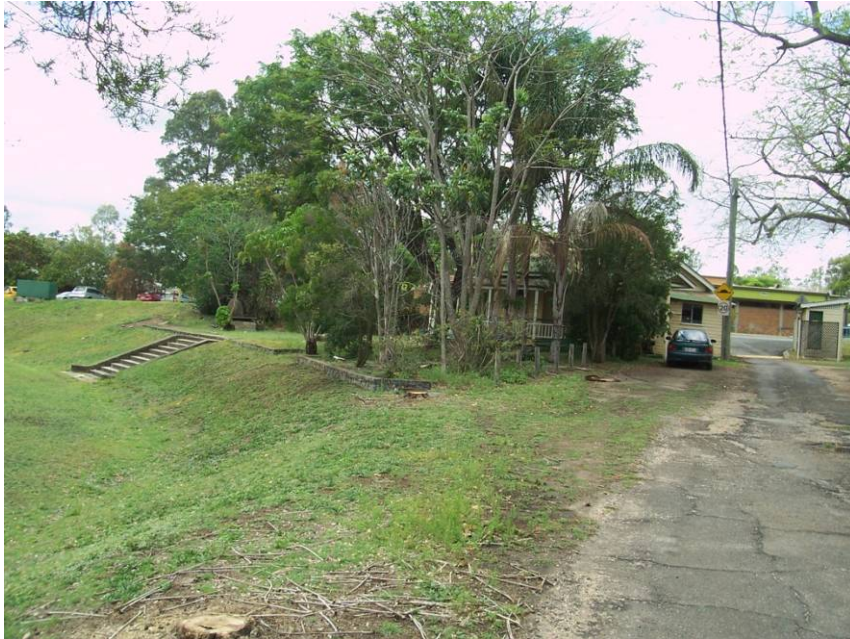
**Figure 29 Photo showing palm trees in the south west corner of the cricket pavilion site. This photo also shows the garden beds and edging along the top of the bank and the bollards along the road edge**

The raised platform on which the pavilion stands is fairly densely planted along the top of the retaining wall to the east, sheltering the pavilion from the road. There is also a group of palm trees in the south west corner of the site. The planting around the cricket pavilion building is recent.

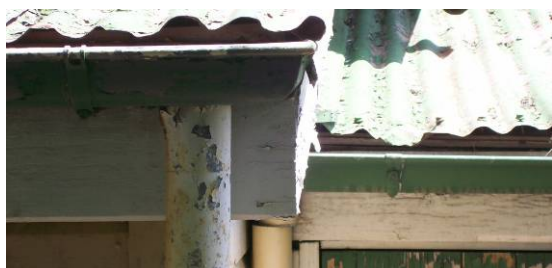
**Figure 31 Photo of quad gutter showing two different types of gutter brackets**

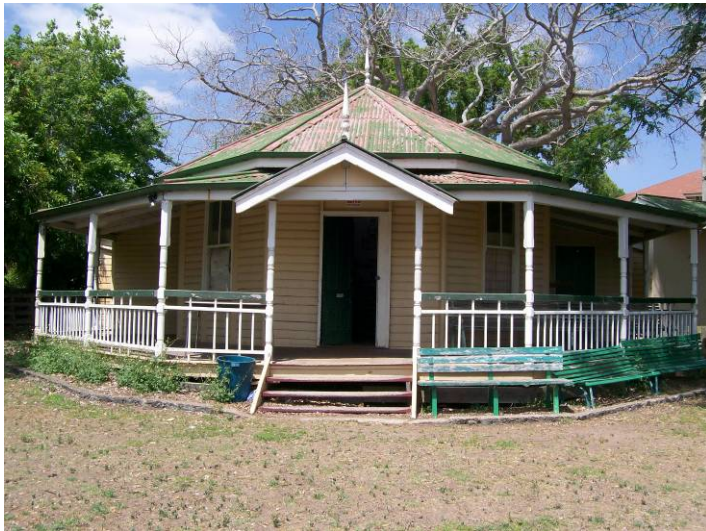
**Figure 32 Cricket Pavilion today from north. The timber stair at the front and the pediment do not show on an early historical site plan in 1896.**

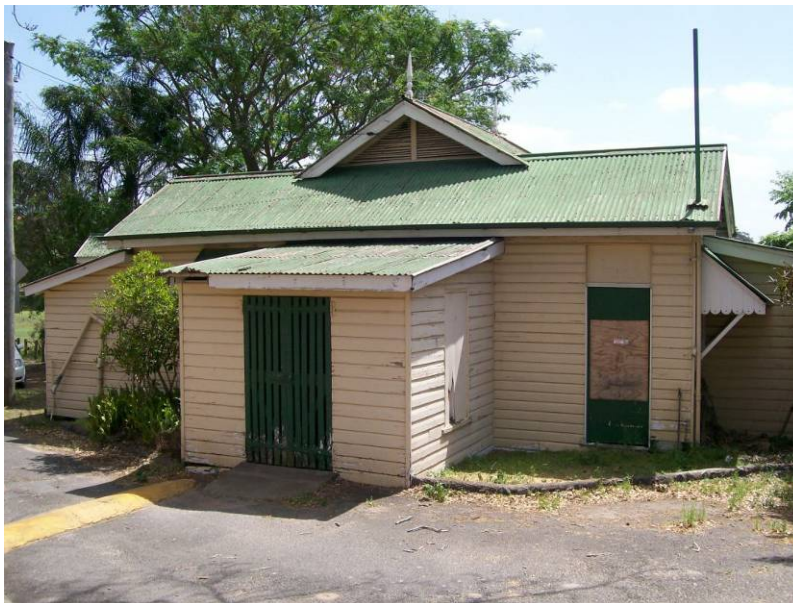
**Figure 33 The southern elevation of the cricket pavilion, showing two parts of the roof meeting and the triangular vent as well as the lean-to additions. The lean-to on the left is the shower room that shows on photographs as early as 1911. The lean-to addition in the foreground is the toolshed and dates to 1913. The lean-to addition on the right shows on the historical block plan from 1936. None of the lean-to additions show in the building outline on historical site plans from 1909 and 1896.**

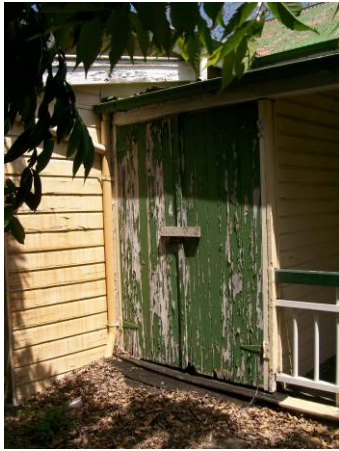
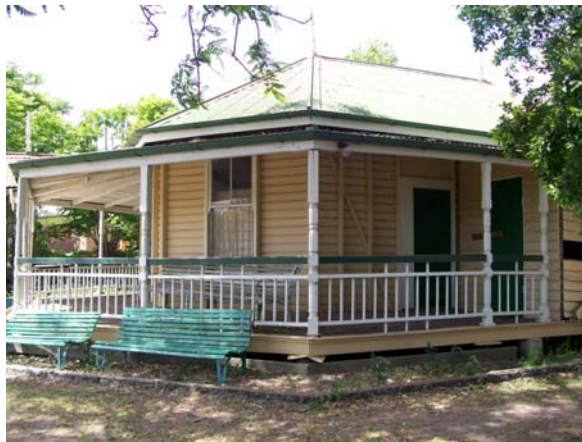
**Figure 34 Photos showing rear sections of the verandah enclosed**

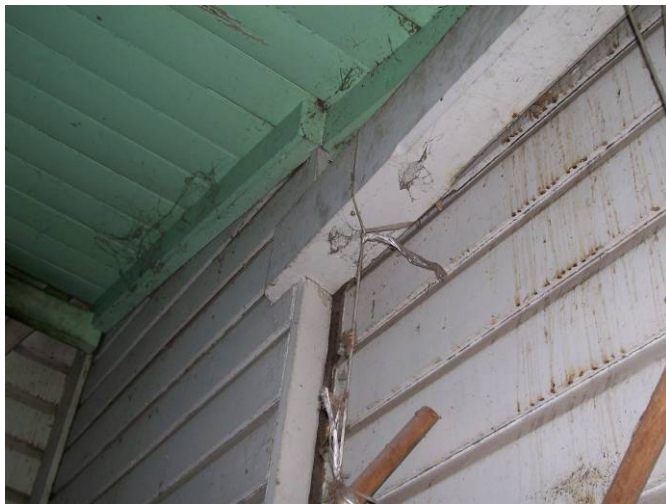
**Figure 35 Joint and end of stop chamfered verandah beam still present inside the enclosed verandah store R9 at the back of R4.**

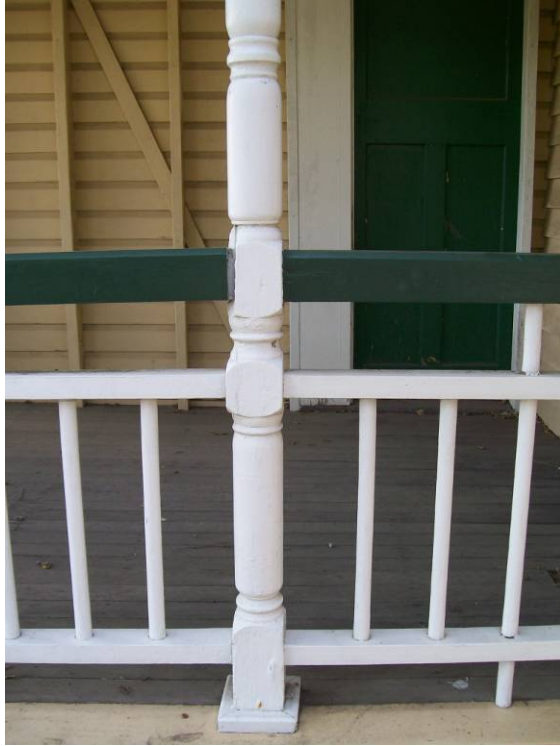
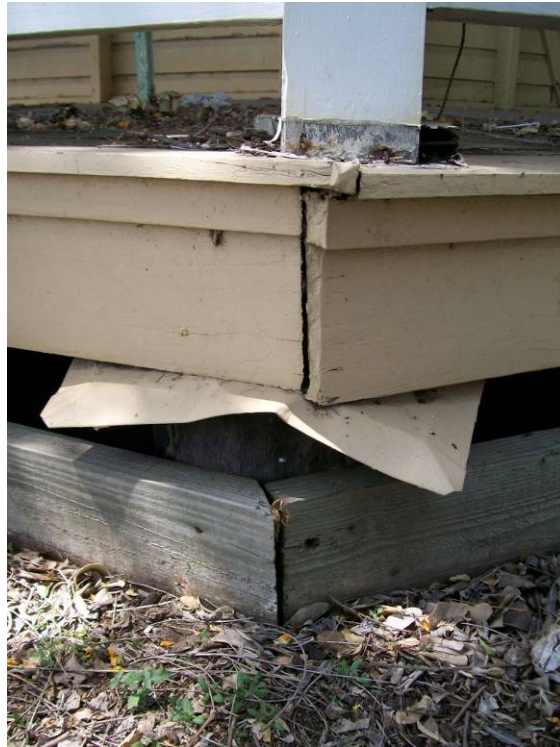
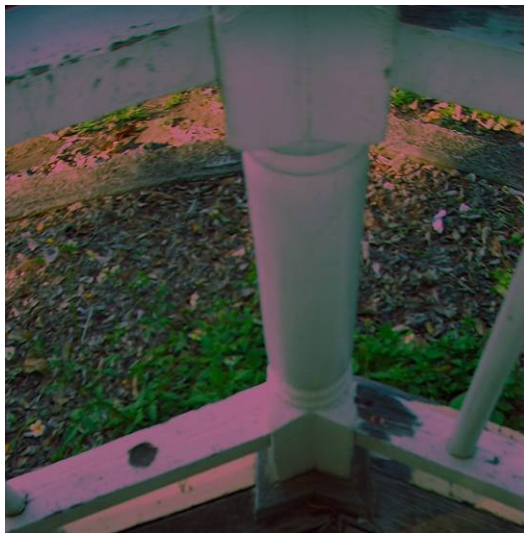
**Figure 36 turned timber verandah posts. The fillets around the bases are not original. The faceted surfaces in some areas suggest they may have been hand finished although this may also be the result of subsequent refinishing.**

**Stumps have been replaced.**

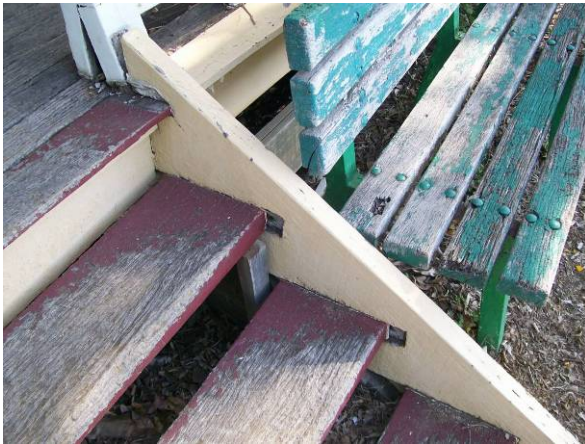
The stair treads at the front entry have been replaced with smaller ones than original.

**Figure 37 Photo showing replace stair treads at the front entry**

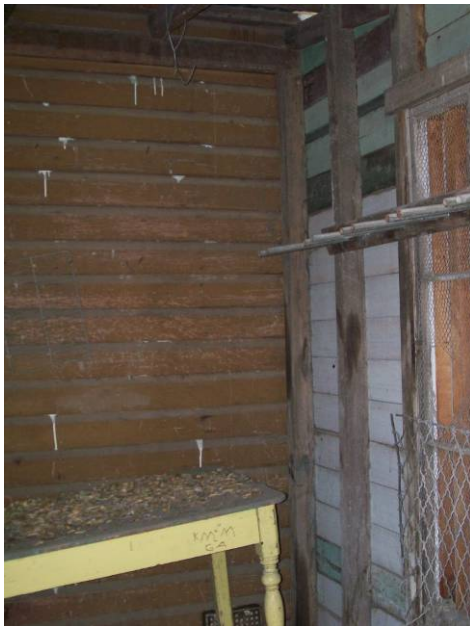
**Figure 38 Photo inside the toolshed showing second hand material and dado paint stripe from a previous location. The tall window sashes on the right have also been recycled. This photo also shows the brown colour (possibly red oxide) on the northern wall inside the toolshed.**

The northern wall inside the toolshed is still painted in the brown colour (possibly red oxide) that would have been a previous external colour of the cricket pavilion.

Generally, the building is single skin to the verandah and internal walls, clad by chamfer boards with 135mm wide cover to all originally external walls of R1, R2 and R3. The boards are beaded on the inside face. Studs are exposed on the verandah. Lean-to and verandah enclosure additions are also clad in chamfer boards, beaded on the inside face with studs exposed internally. The partition between the main room R1 and the back rooms R2 and R3 is clad in horizontal beaded boards. Other internal partition walls between R2 & R3 and R6 & R7 are clad with VJ boards. The cladding to the toolshed and stores is second hand material in matching size and profiles probably from original hospital buildings.

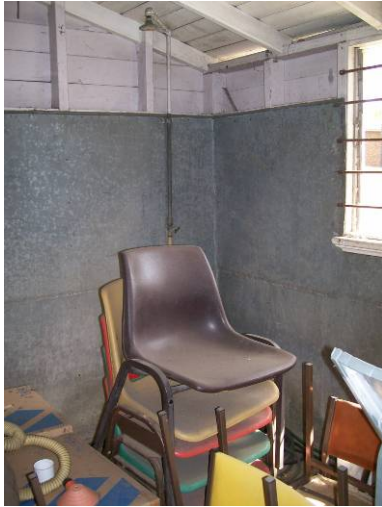
The shower room has a galvanised flat iron shower recess with beaded edge and an early shower fixture. The manufacturer's mark is visible but is illegible.

**Figure 39 Photo inside the shower room**

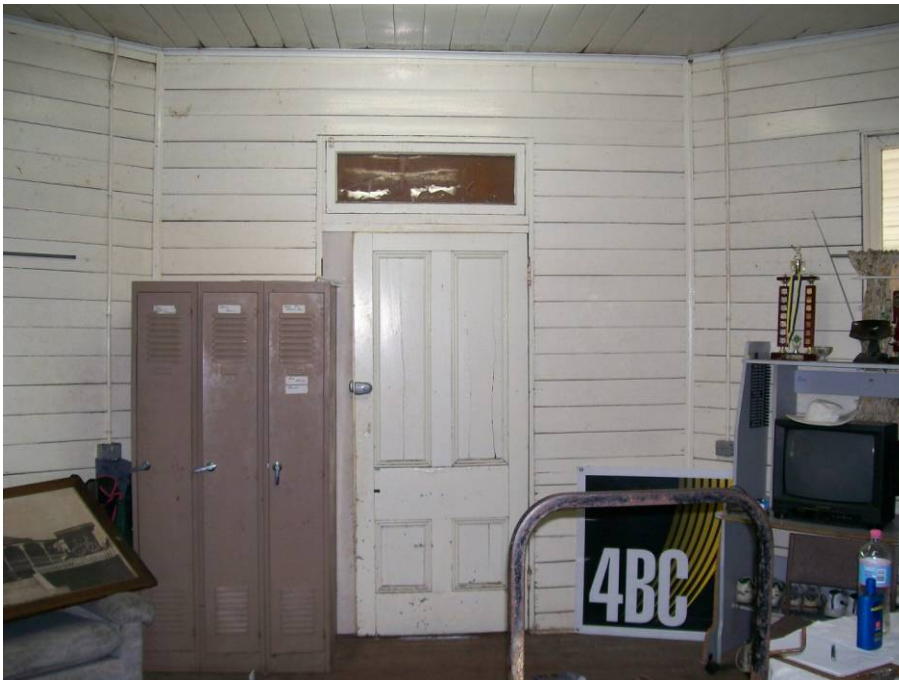
**Figure 40 Photo showing internal elevation to the north inside R1. The four panel door has been recycled in the opening originally intended for French doors. The fanlight is original.**

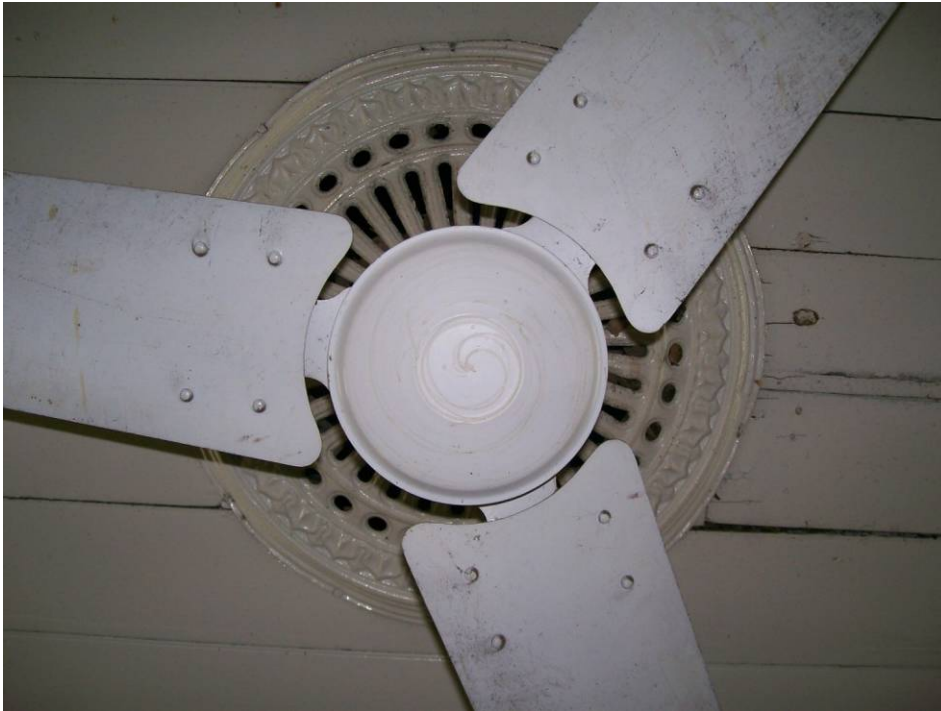
**Figure 41 Ceiling and ceiling rose in R1**

Ceiling height is generally 3010mm to the top of the studs and 3080mm to the ceiling lining. There are pressed zinc ceiling roses in R1, R2 & R3. The ceiling rose itself is missing from R3. Cornices, where they exist, are generally scotia profile except in R3 which has a batten cornice.

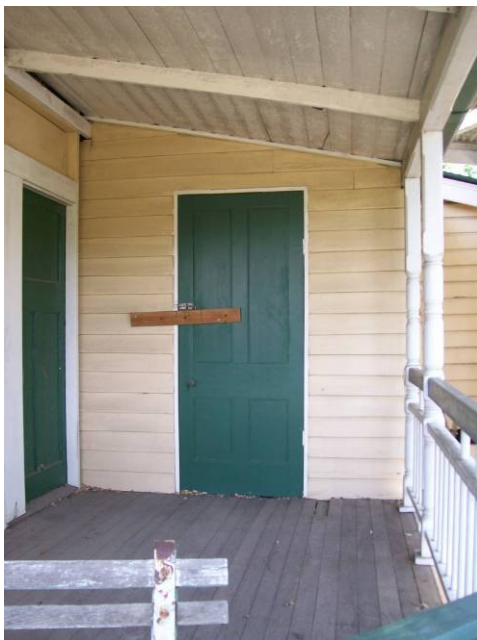
**Figure 42 Photo showing raking verandah ceiling, hardwood tongue and groove floor and D4 into R9. To the right the French door opening survives.**

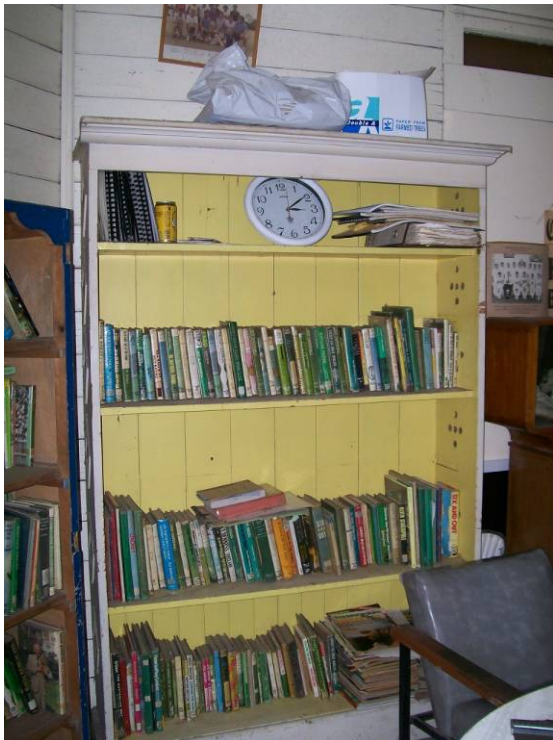
**Figure 43 Bookcase in R1**

The main room R1 has a bookcase in similar moulded style and painted the same colour as the room linings.

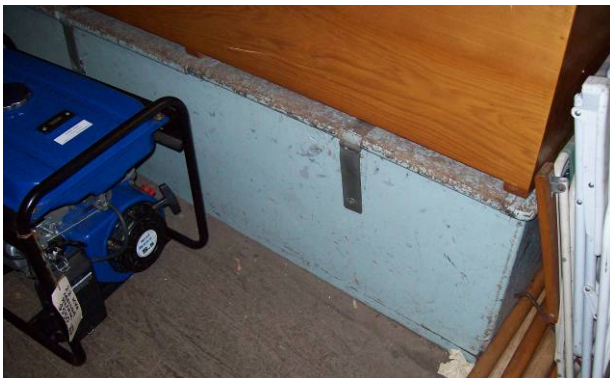
The change room (R2) contains an early locker which appears to have stood in the main room R1 against the back wall. This is evident from a break in the quad skirting trim and marks on the floor which correspond with the size and shape of the locker.

**Figure 44: Original locker stored in Room 2**

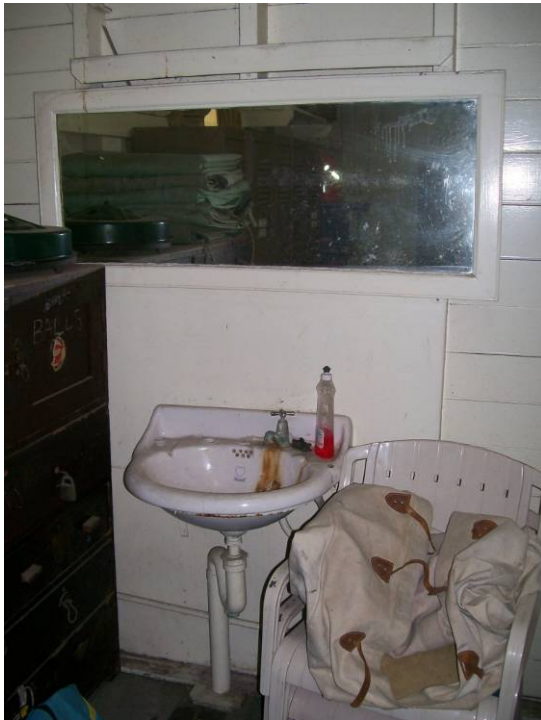
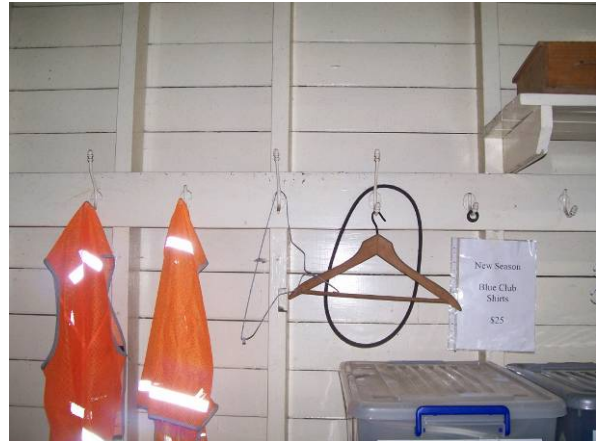
**Figure 45 Photos of basin (above) and hooks (right) in R2**

The change room R2 has some early coat hooks with porcelain ends (unpainted) on the rail, a timber shelf and a wall basin with metal splashback and hung mirror reused from elsewhere.

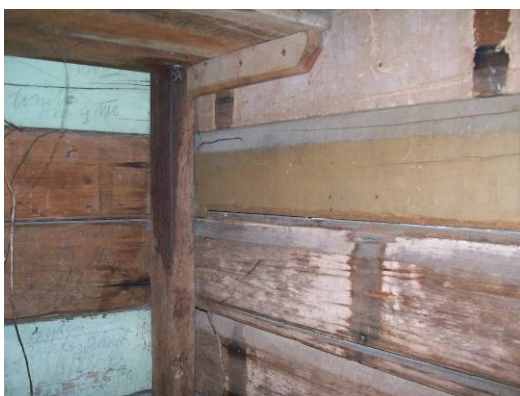
**Figure 46 Photo showing underside of timber shelf in R6 and recycled chamfer boards**

There is an early timber shelf in the pantry R6.

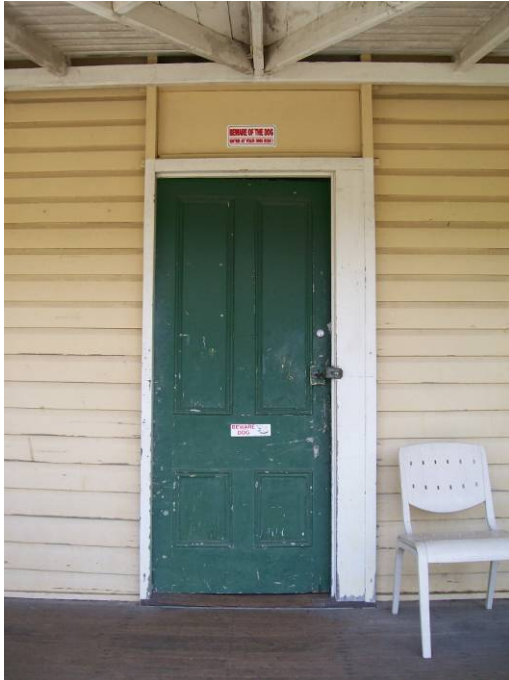
**Figure 47** Example of tusk tenon jointed framed door opening onto the verandah reduced for a 4 panel door. This would have original been a set of French doors with a fanlight.

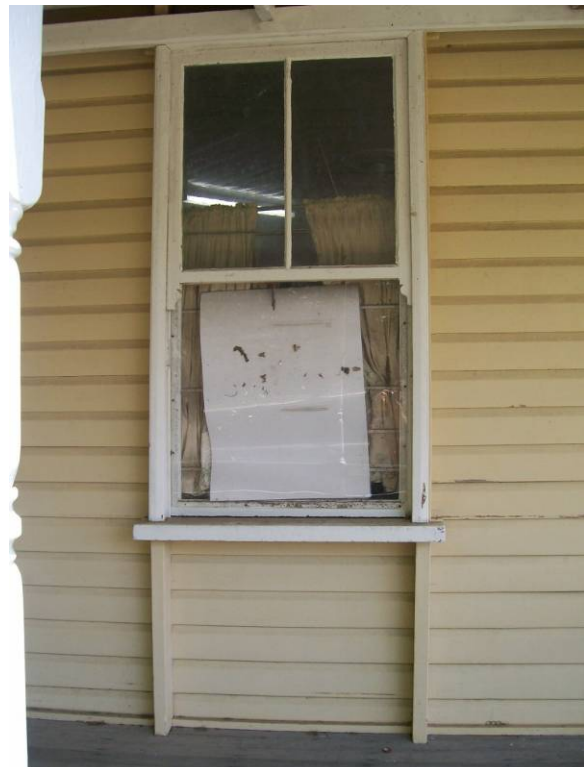
**Figure 48** Elevation of W1 with tusk tenon joints

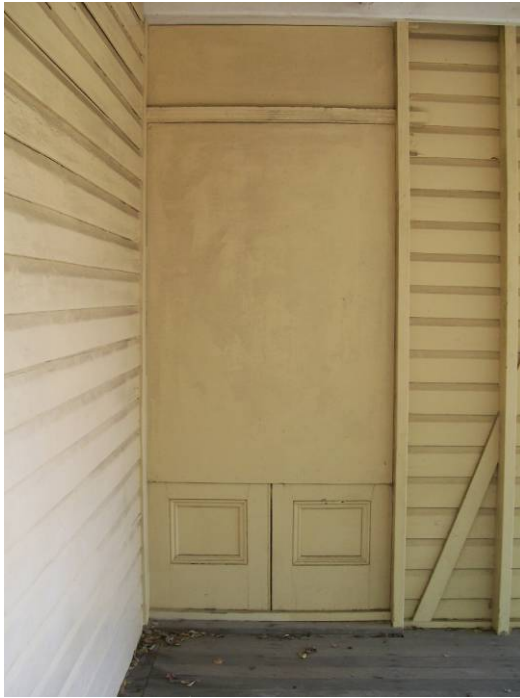
**Figure 49 Elevation of D1, French doors that have been boarded up.**

One set of French doors, D1, survives onto the verandah. The other French doors, D2 & D3, have been replaced but the frame and fanlights remain. D2 and D3 openings have been reduced for 4 panel doors. It is possible that the door leaf from D10 is now in D2.

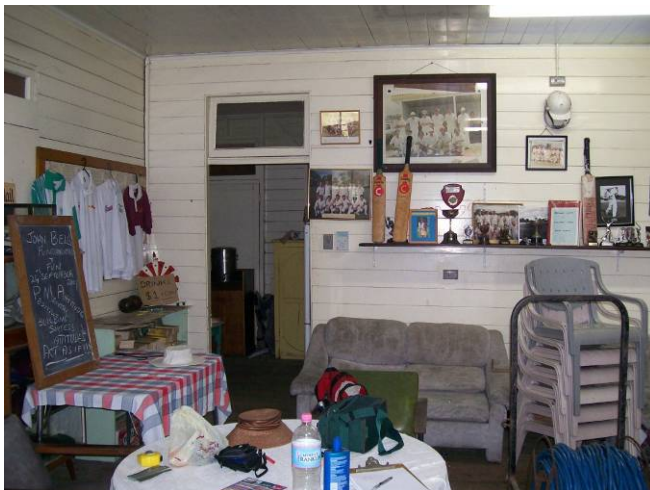
**Figure 50 internal elevation towards the south in R1 showing D9, including fan light. This door probably incorporated a four panel door leaf.**

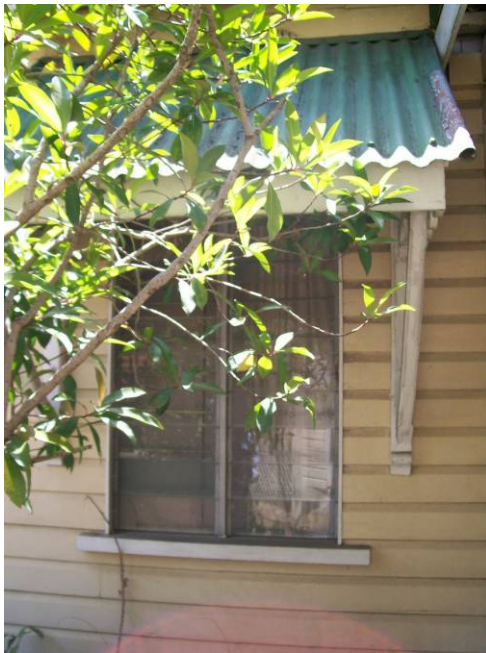
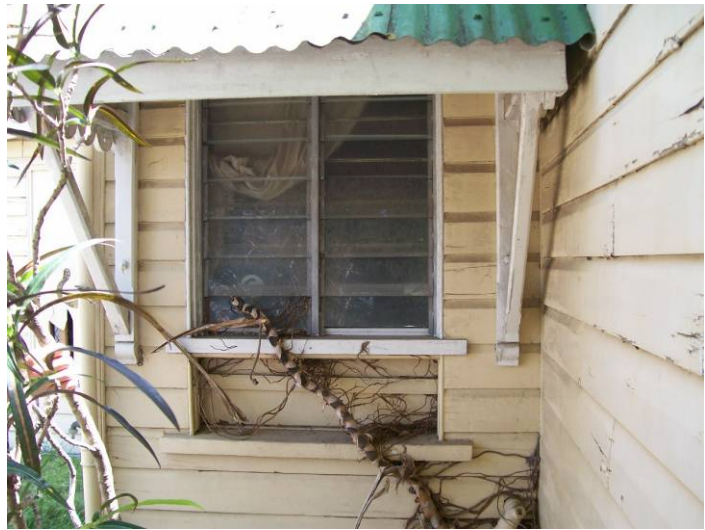
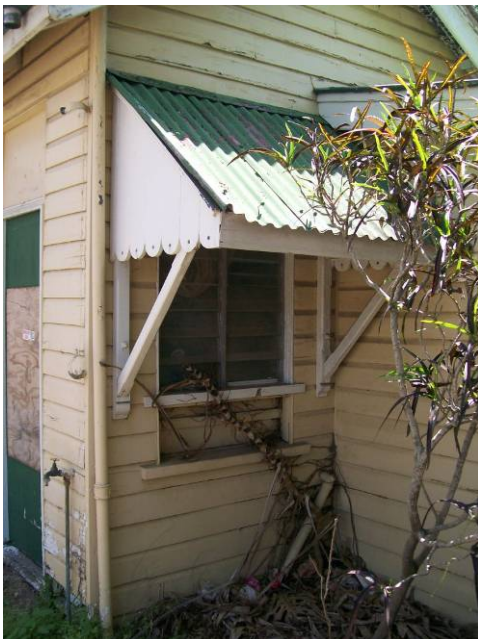
**Figure 51 Elevations of W4 (above left) and W7 (above right and below left) and photo showing perspective view of hood to W7. Both W4 and W7 have original external hoods. Note W7 has original sill.**

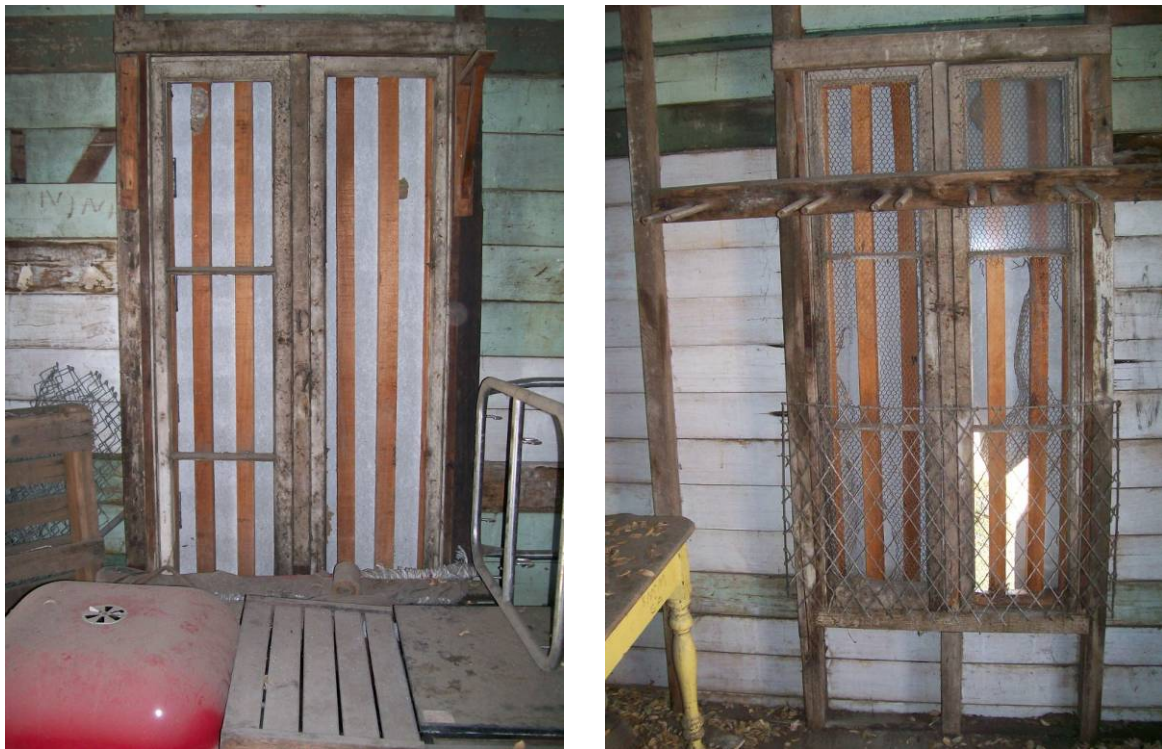
**Figure 52 Internal elevations of W5 (left) and W6 (right)**

The windows in the toolshed, W5 & W6, now blocked up, are both pairs of 3 pane casement sashes, possibly recycled. The sashes are tall and narrow and appear to be early, possibly from the original hospital. The window opening size is similar to what the original opening sizes of W4 and W7 appear to have been.

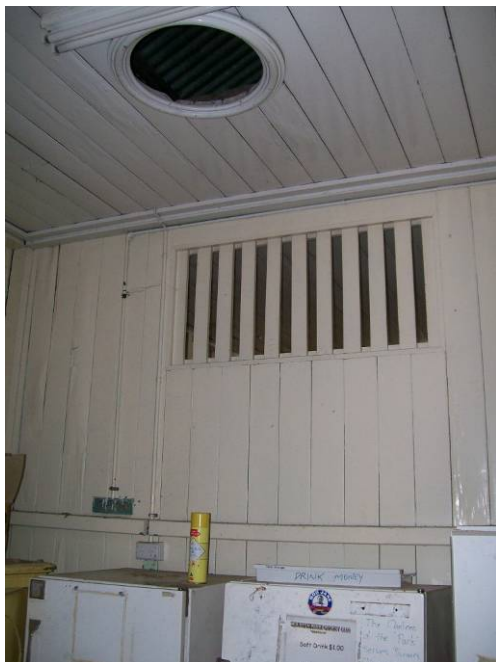
**Figure 53 Photo showing slatted high level opening between R2 and R3. This photo also shows the ceiling rose missing in R3 and the mortise in the rail of the single skin wall for the power to come down to the power point above the fridge.**

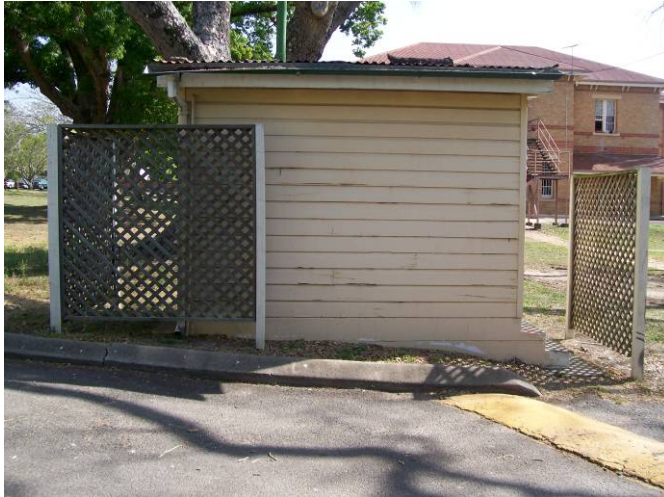
The lavatory shed is a single storey, single skinned timber building with a skillion corrugated metal roof. It sits on a raised concrete base with concrete steps at both entries into a ladies section and into a gents section. Lattice screens of recent detail have been erected.

**Figure 54 North eastern elevation of lavatory shed**

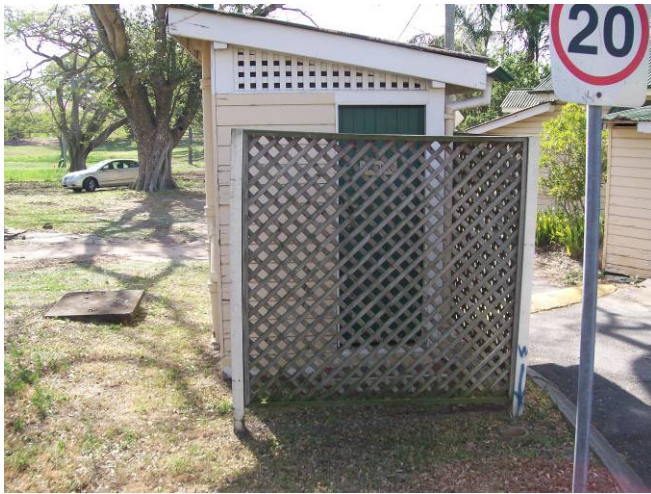
**Figure 55 south eastern elevation of the lavatory shed**

External cladding is chamfer board, recycled in some areas. External doors are VJ ledged and braced. Internal cladding is VJ boarding, partly covered with FC on the ladies' side. Internal doors are  $\frac{3}{4}$  height and undercut.

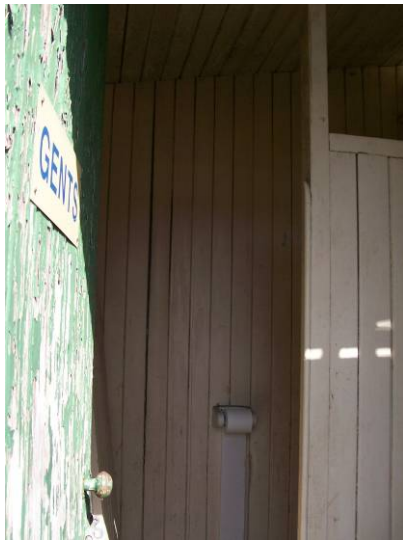
**Figure 56 (left) through the entry door onto the gents**

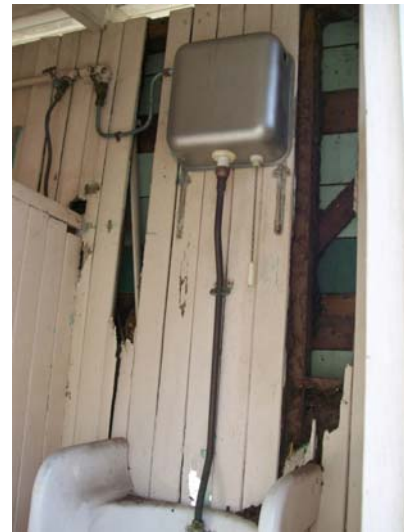
**Figure 57 (right) photo showing urinal cistern in gents, as well as recycled external cladding and internal VJ cladding. The external cladding has the same colouring and dado stripe detail as other recycled materials in the cricket pavilion building itself.**

High level cisterns have been removed.

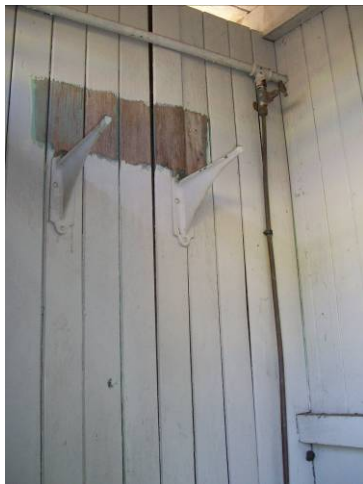
**Figure 58 Location of previous high level cast iron cistern in ladies.**

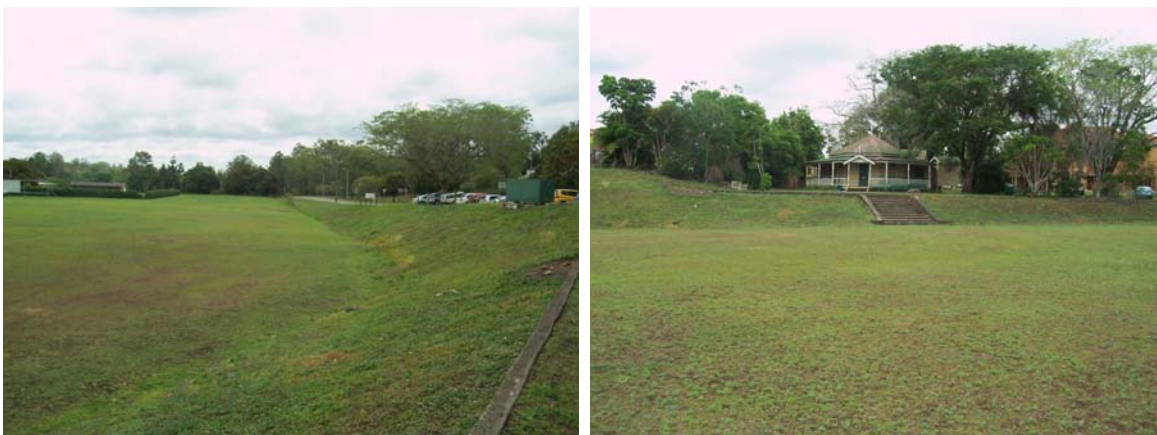
**Figure 60** Photo on left shows blocked grass drain around the edge of the oval. Photo on the right shows excessive vegetation around the cricket pavilion
