# CRICKET PAVILION AND OVAL WOLSTON PARK HOSPITAL CONSERVATION PLAN

*Prepared for:*  
Queensland Police Service  
Address

*Prepared by:*  
Project Services  
80 George Street, Brisbane

January 2008

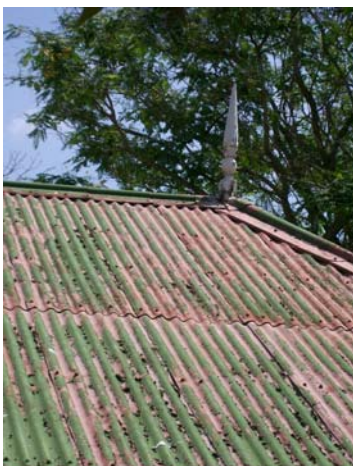
**Figure 61** Roof at front showing finial and sheeting

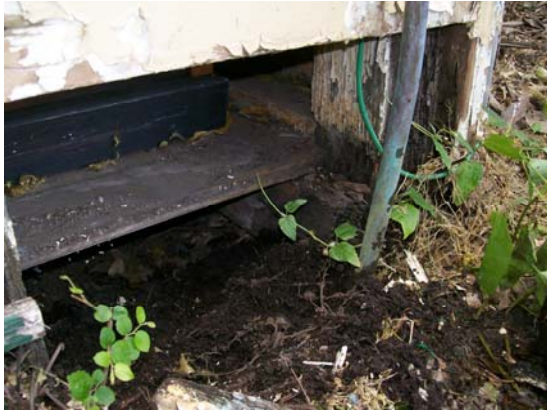
**Figure 62 deteriorated bottom plate at the south**

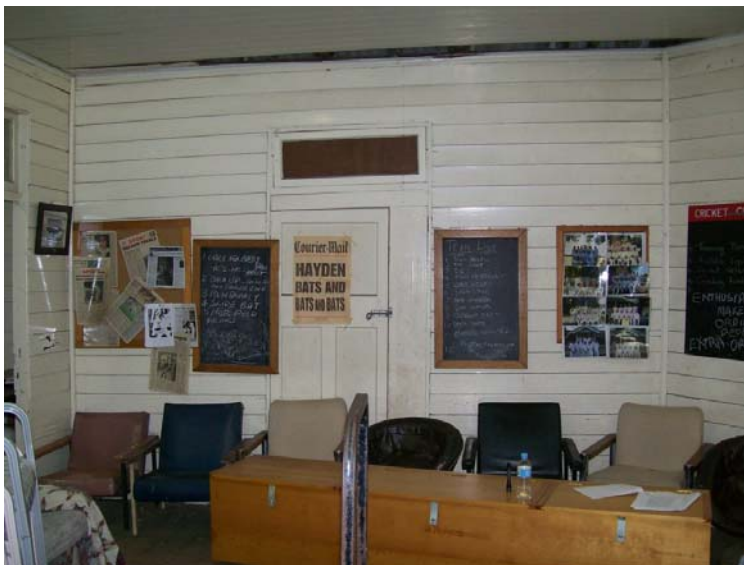
**Figure 63 Note termite damage to ceiling and wall**

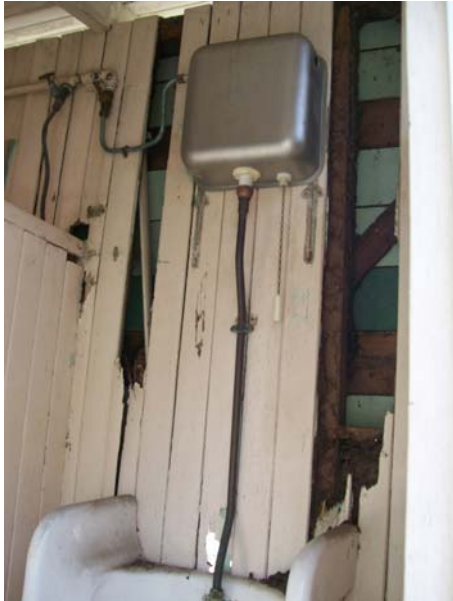
**Figure 64 (above left) Note extensive termite damage to southern wall of lavatory block**
